Rate effect on Halden silt

Triaxial testing with different rates of loading

Trondheim, December 2019

PROJECT THESIS: TBA4510

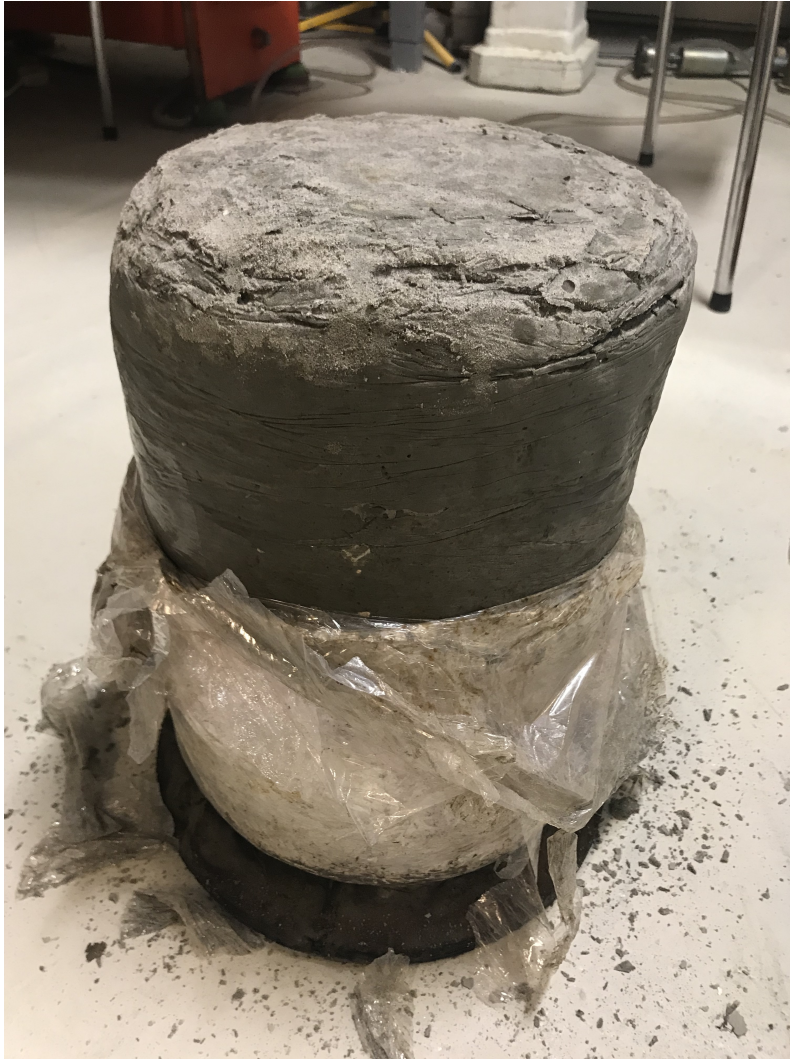
Figure 2.1: The block sample used in the tests

The block sample was collected using a Sherbrooke block sampler with $\Phi 250$ mm. The block was taken from 15.15-15.5 meter below the surface and has been stored in a fridge after transportation to Trondheim, Norway. The block has to be cut in different parts to be able to tested. Since the triaxial apparatus used in this project requires a final sample height of 10 cm, the block is split in half. By cutting the block in half, ten samples can be cut out of the block for testing. First the sample was taken out of the container, and the plastic film was removed. The first observation is that the outside of the block seemed quite dry. The material was easy to fracture simply by touching it. The state of the block sample can be observed in Figure 2.1. The crust at the top and the sides were completely dry. Shell fragments could be seen when the top of the block were examined further.

First, the block were trimmed by 3 cm at the top. A circle of about 2 cm around the edges was rather dry. The block was in good condition apart from the dry edge. Furthermore, there was observed a small black circle with some organic material. There was also detected that the block contained a substantially amount of shells. One of the shells in the top was quite big compared

to most of the other inspected shells. When the block was trimmed the shells got stuck in the steel wire, which made the process somewhat difficult. The larger shell made quite the hole in the block and disturbed the sample a bit.

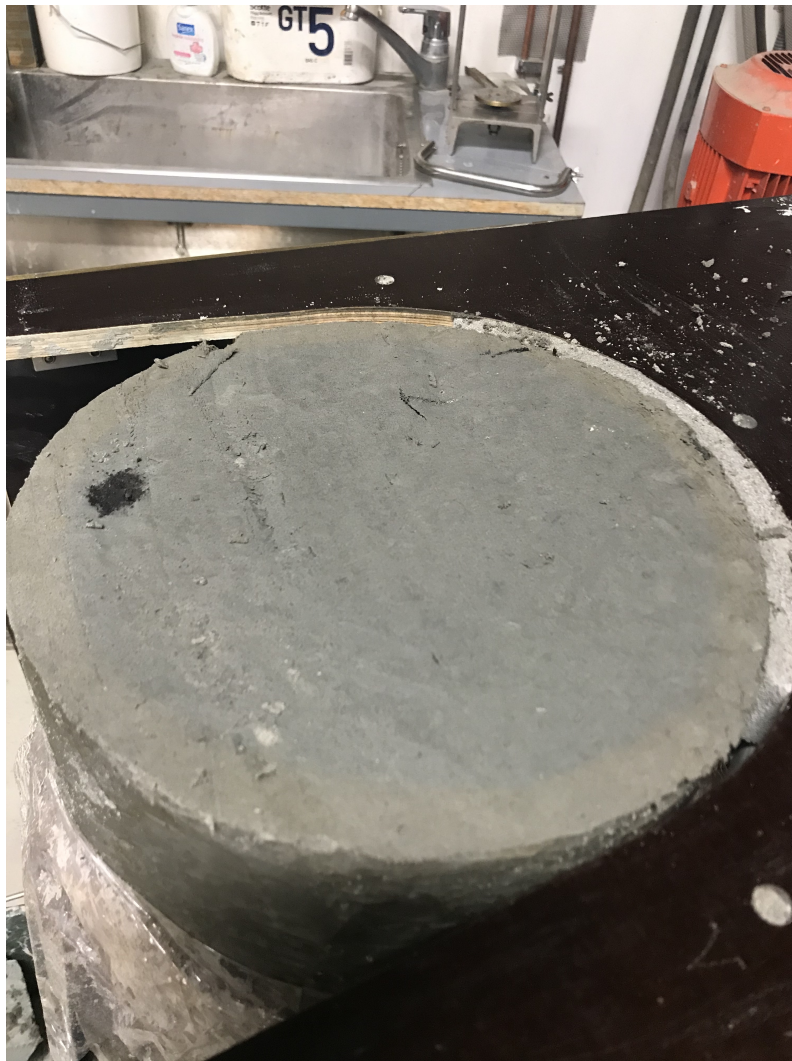
Figure 2.2: The block sample after trimming at the top

From Figure 2.2 it is possible to witness the V-shaped mark where the shell was placed. The dark organic material can also be seen.

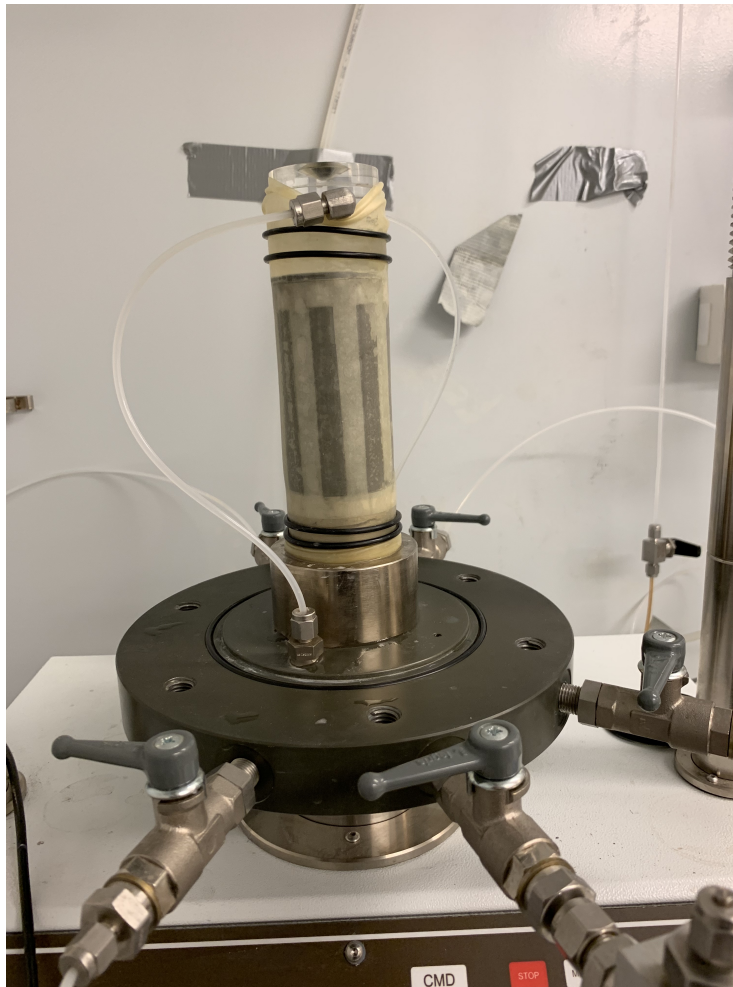
Figure 2.5: The sample prepared for testing

The result from the building into the apparatus can be observed in Figure 2.5 below:

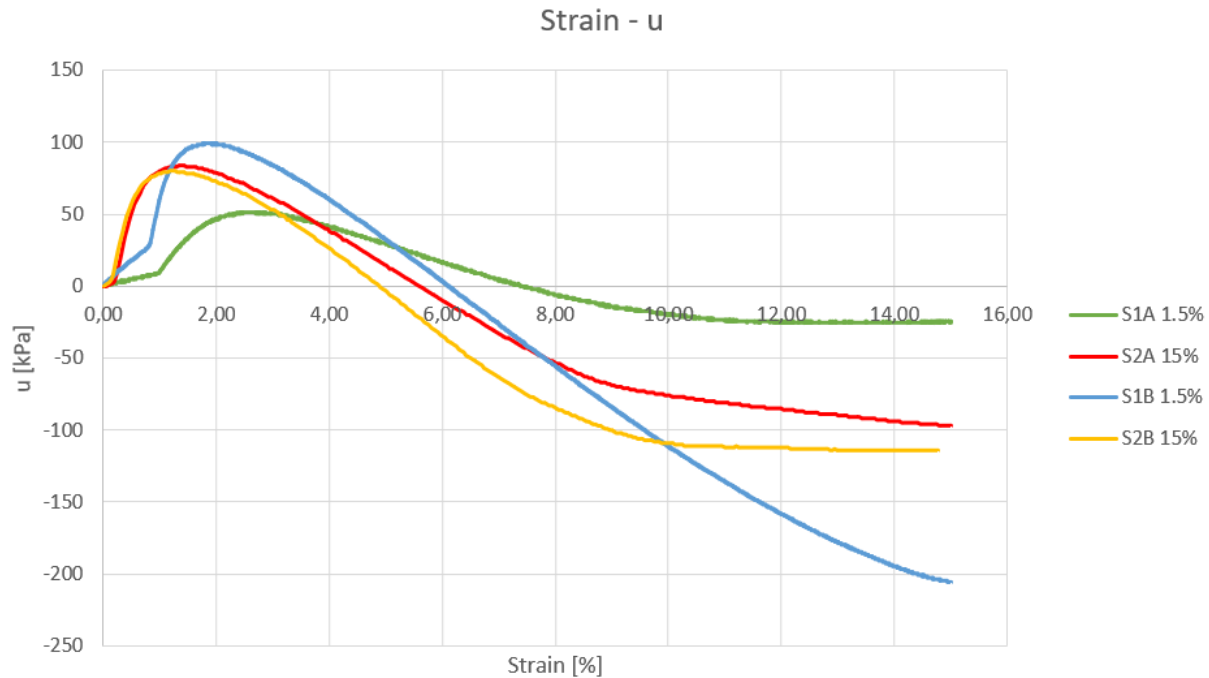
Figure 3.1: Plot showing Strain versus the change in pore pressure

Method (a) is describes further in this section. Figure 3.1 shows strain plotted versus ΔU . By

reading the graph where the highest pore pressure is obtained, the corresponding deviatoric stress is found in Figure 3.2. The undrained shear strength is found by dividing the deviatoric stress by 2. The deviatoric stress is found using Equation 3.2:

Overall results observed in the plots: By investigating Figure 3.1, a strange behavior in sample 1B is displayed. The peak value is higher than the values for the samples sheared at 15%, which should not be the case. This might be due to some disturbance in the sample, a measuring error in the equipment or a personal mistake when running the test. This behavior can further be seen in Figure 3.2, where the blue line (1B) is almost as high as the samples sheared at 15%. Further, the Figures 3.3 and 3.4 indicates that sample 1B is resulting in a higher S_u .
